The Fire Resistance Performance of a Non-Loadbearing Ceiling Assembly Incorporating Five Extract Fans With Closure Devices Tested Generally In Accordance with BS EN 1364-2: 2018 And Additional Guidance From BS EN 1366-3: 2009

424611

Quelfire Ltd

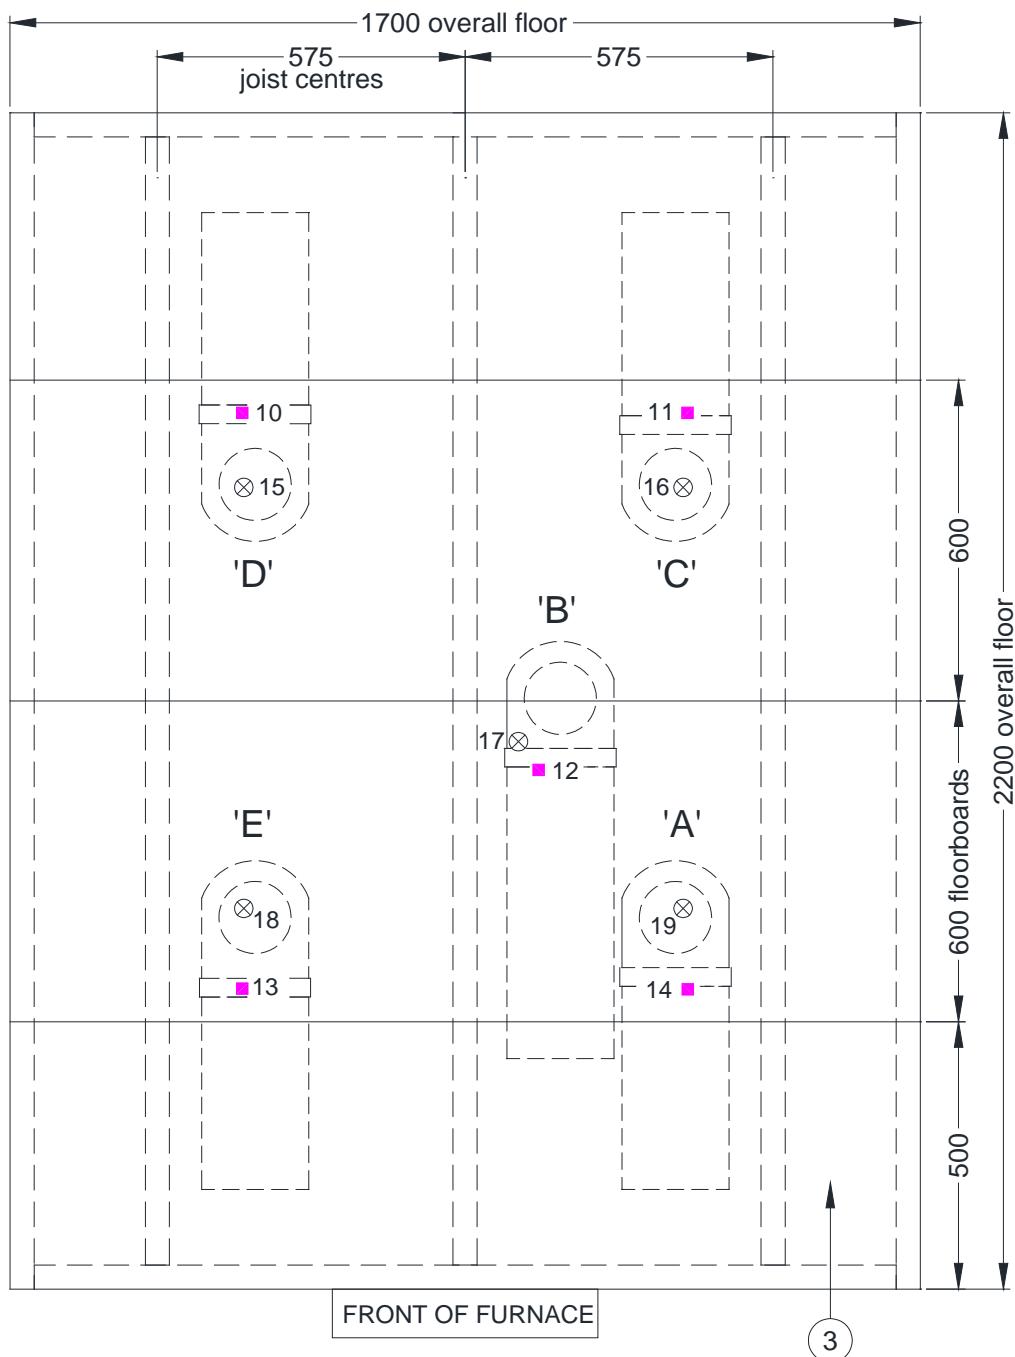
Figure 1 – General plan view from unexposed face and thermocouple positions

Positions of thermocouples

- surface mounted thermocouples on floorboards (nos.10 to 14)
- ⊗ air temperature thermocouples within timber floor cavity (nos.15 to 19)

GENERAL PLAN VIEW OF UNEXPOSED FACE  
AND THERMOCOUPLE POSITIONS

<b>Instruction to Test</b>	The test was conducted on the 24th March 2020 at the request of Quelfire Ltd, the test sponsor.  Mr. D. Wells a representative of the test sponsor witnessed the test.
<b>Ambient Temperature</b>	The ambient air temperature in the vicinity of the test construction was 18°C at the start of the test with a maximum variation of +4°C during the test.
<b>Furnace</b>	The furnace was controlled so that its mean temperature complied with the requirements of BS EN 1363-1: 2012 Clause 5.1 using four plate thermometers, distributed over a plane 100 mm below the surface of the test construction.
<b>Thermocouples</b>	Thermocouples were provided to monitor the unexposed surface of the specimen. The output of all instrumentation was recorded at no less than one minute intervals. The locations and reference numbers of the various unexposed surface thermocouples are shown in Figure 1.

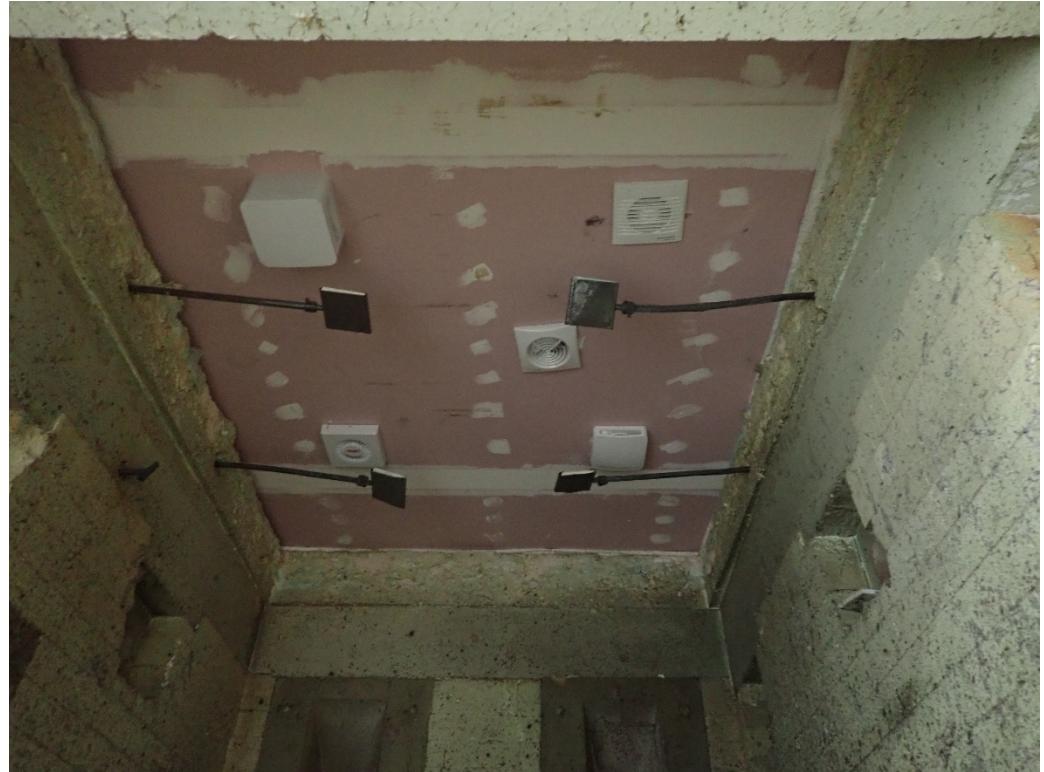
**The exposed face  
of the specimen  
prior to testing**

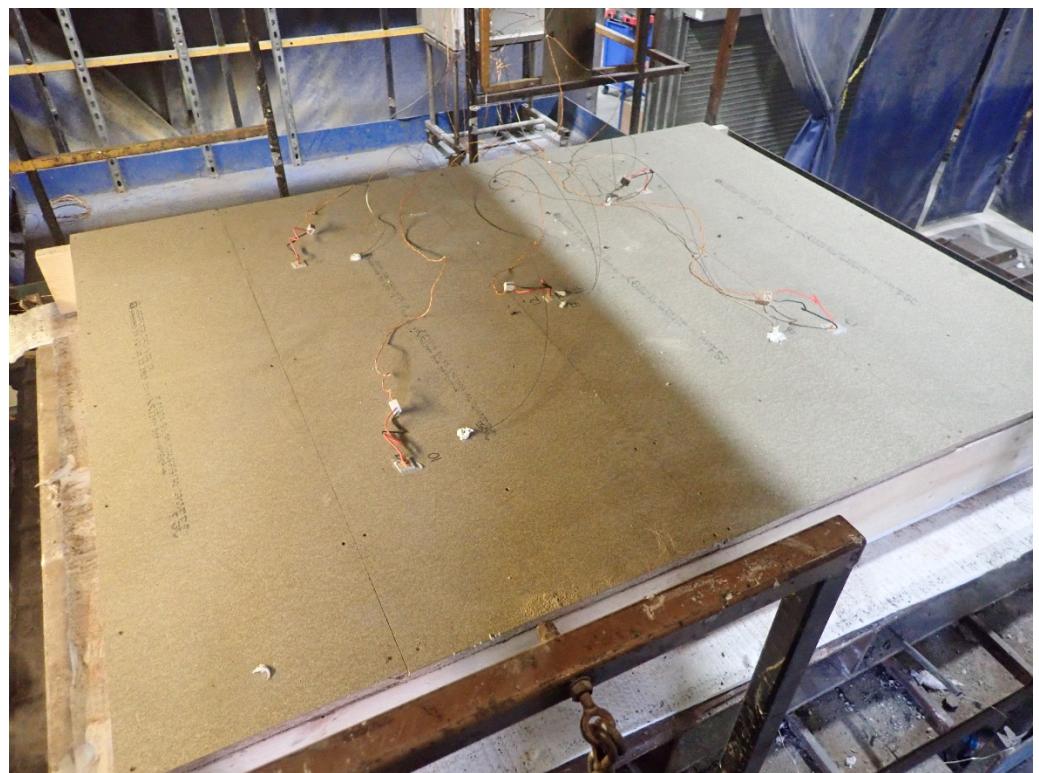
**The unexposed  
face of the  
specimen prior to  
testing**

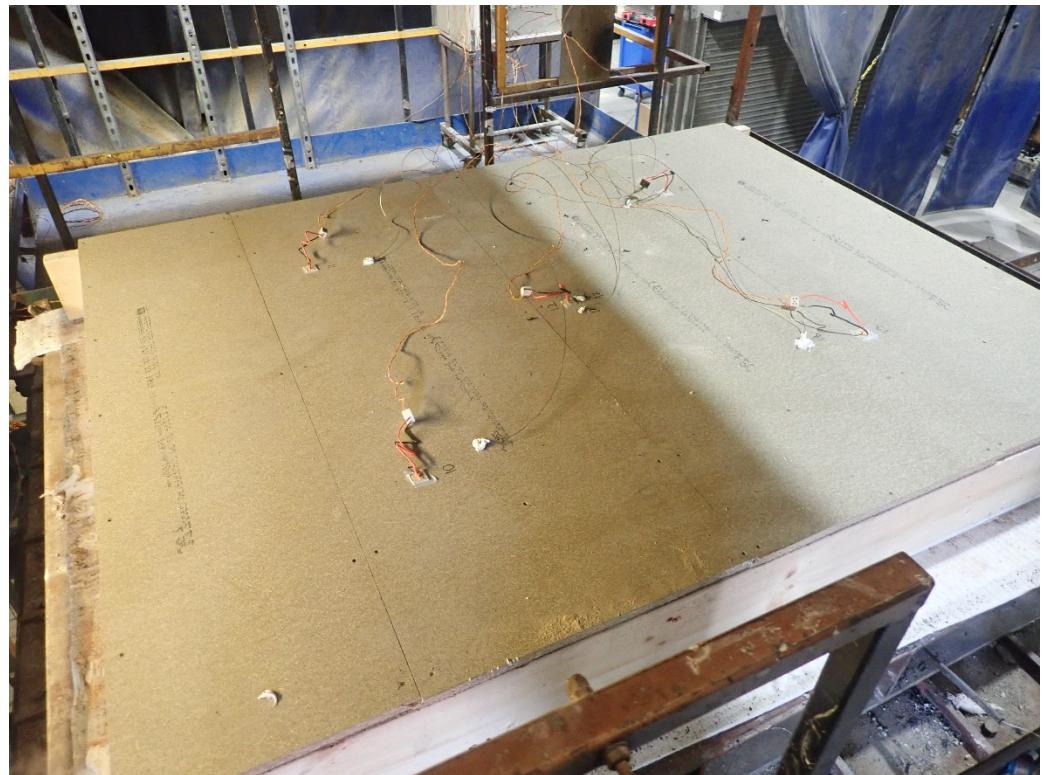
The unexposed face of the specimen after a test duration of 30 minutes

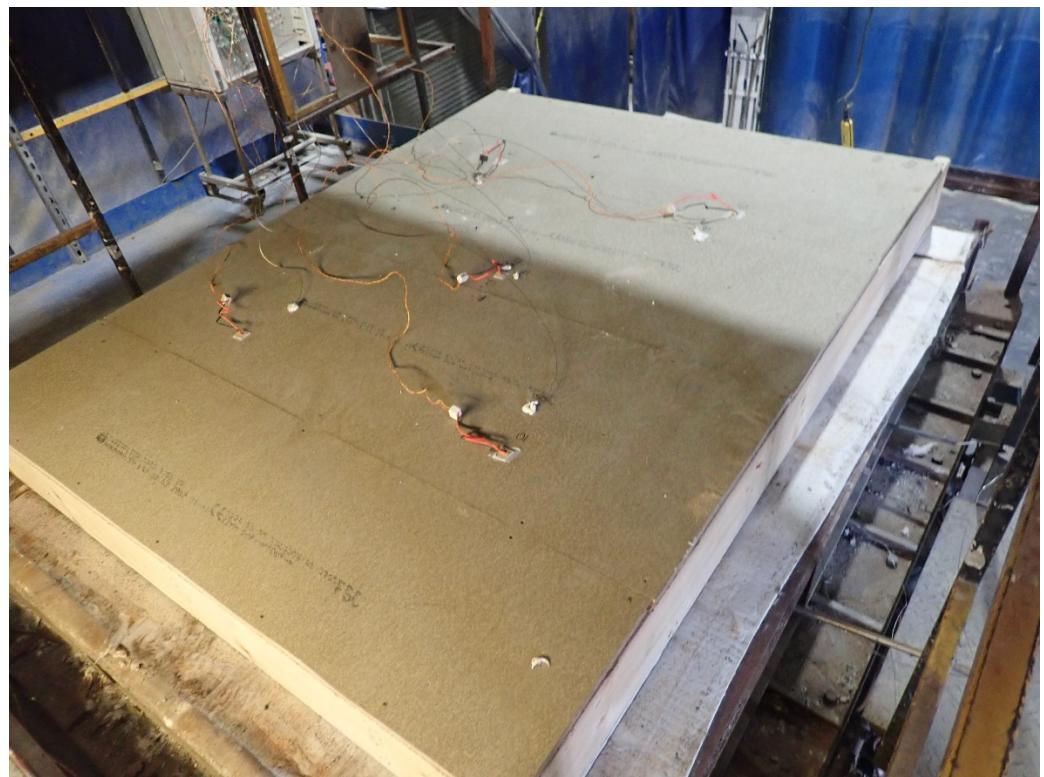
The unexposed face of the specimen after a test duration of 60 minutes

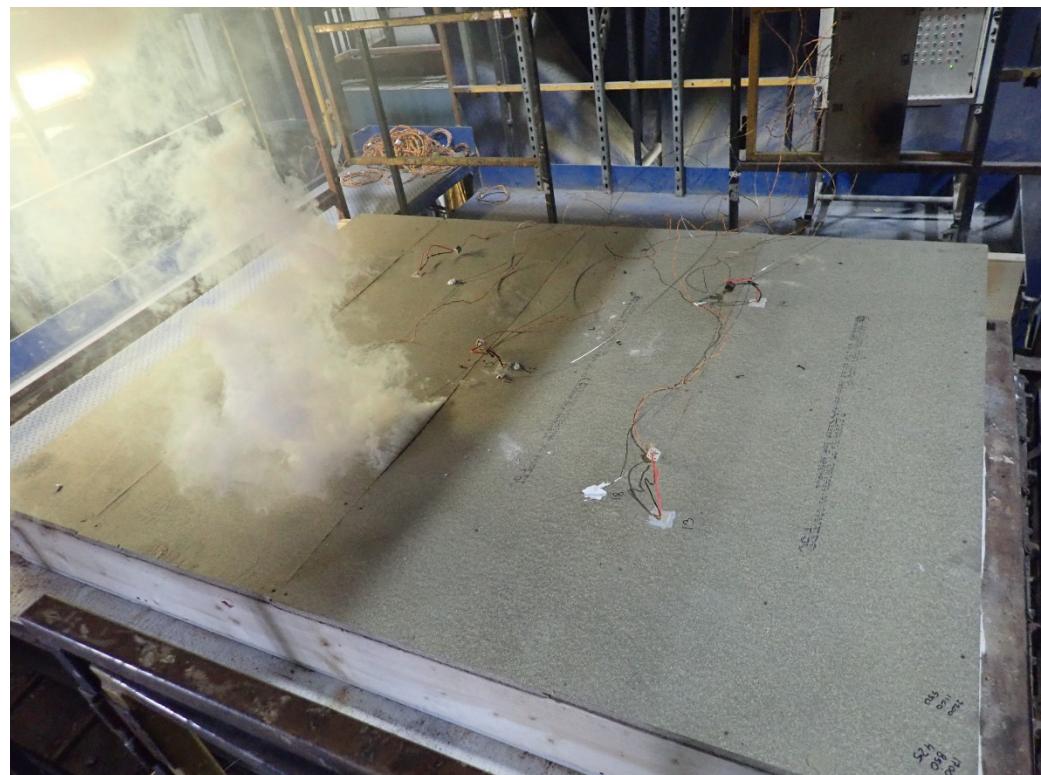
The unexposed  
face of the  
specimen after a  
test duration of  
99 minutes

78	00	Cracks have formed between the apertures on the exposed face.
85	00	Sections of plasterboard have detached around Services C and E.
90	40	Second layer of board, joint opening up on the exposed face.
95	40	Smoke release increased from the joints in the tongue & groove floor board.
99	00	<b>Test discontinued.</b>

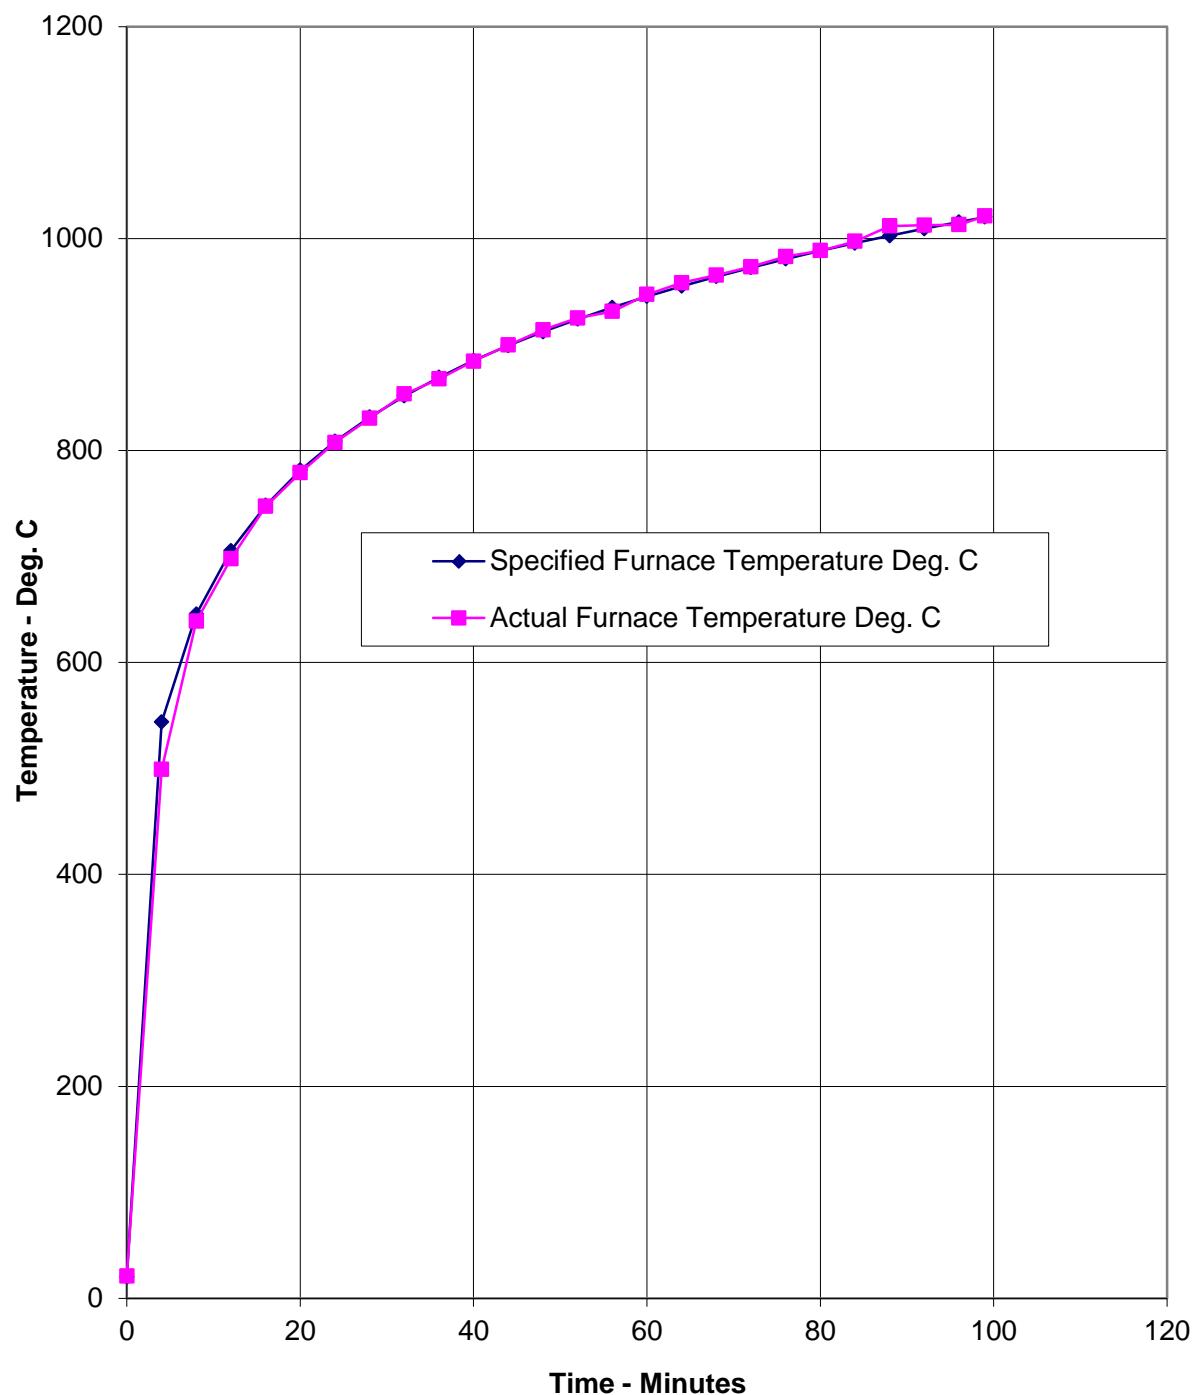
**Graph Showing Mean Furnace Temperature, Together With The Temperature/Time Relationship Specified In The Standard**

Time Mins	Specified Furnace Temperature Deg. C	Actual Furnace Temperature Deg. C
0	20	21
4	544	499
8	645	639
12	705	698
16	748	747
20	781	779
24	809	808
28	832	830
32	851	853
36	869	868
40	885	884
44	899	900
48	912	914
52	924	925
56	935	931
60	945	947
64	955	958
68	964	966
72	973	973
76	981	983
80	988	989
84	996	997
88	1003	1012
92	1009	1013
96	1016	1013
99	1020	1021

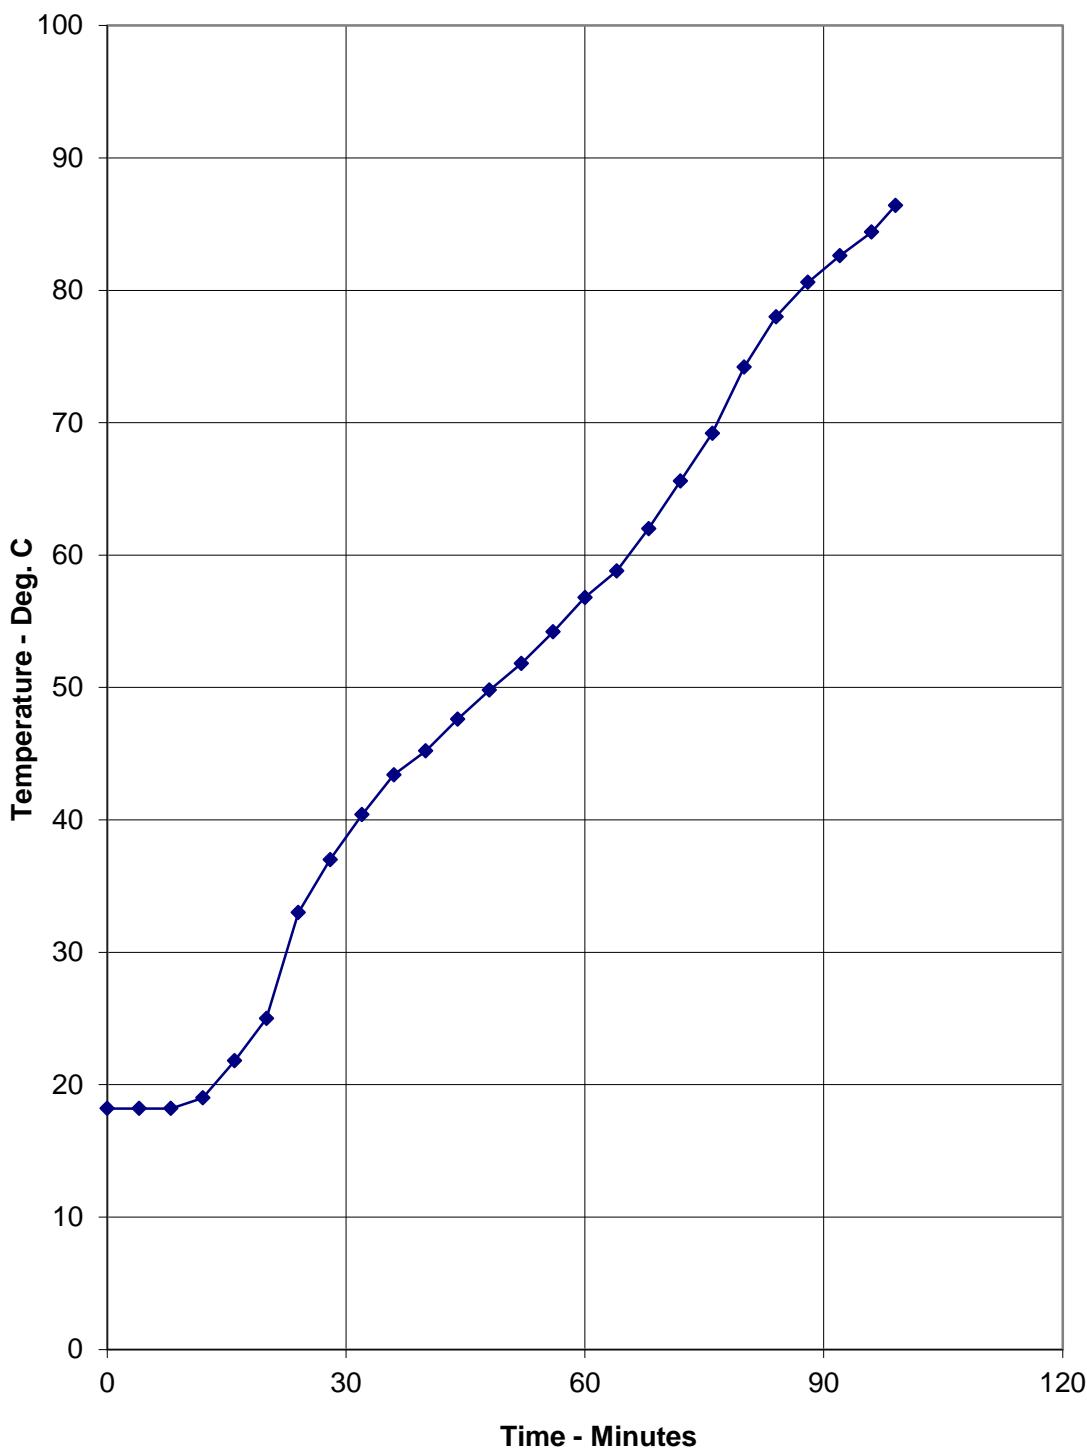
**Graph Showing Mean Temperature Recorded On The Unexposed Surface Of The Specimen**

Time Mins	T/C Number	T/C Number	T/C Number	T/C Number	T/C Number	Mean
	10 Deg. C	11 Deg. C	12 Deg. C	13 Deg. C	14 Deg. C	Temp Deg. C
0	19	17	18	19	18	18
4	19	18	18	19	17	18
8	19	18	18	19	17	18
12	21	20	19	20	15	19
16	26	26	21	23	13	22
20	34	32	23	26	10	25
24	43	38	25	29	30	33
28	50	44	27	32	32	37
32	57	48	29	34	34	40
36	63	51	31	37	35	43
40	66	54	33	39	34	45
44	70	56	35	41	36	48
48	73	58	37	43	38	50
52	77	61	38	44	39	52
56	82	65	40	45	39	54
60	85	70	42	47	40	57
64	86	74	44	49	41	59
68	88	79	48	54	41	62
72	88	84	54	60	42	66
76	89	86	60	66	45	69
80	91	87	72	71	50	74
84	92	87	82	75	54	78
88	94	88	84	79	58	81
92	95	89	86	81	62	83
96	97	90	84	84	67	84
99	98	92	84	86	72	86

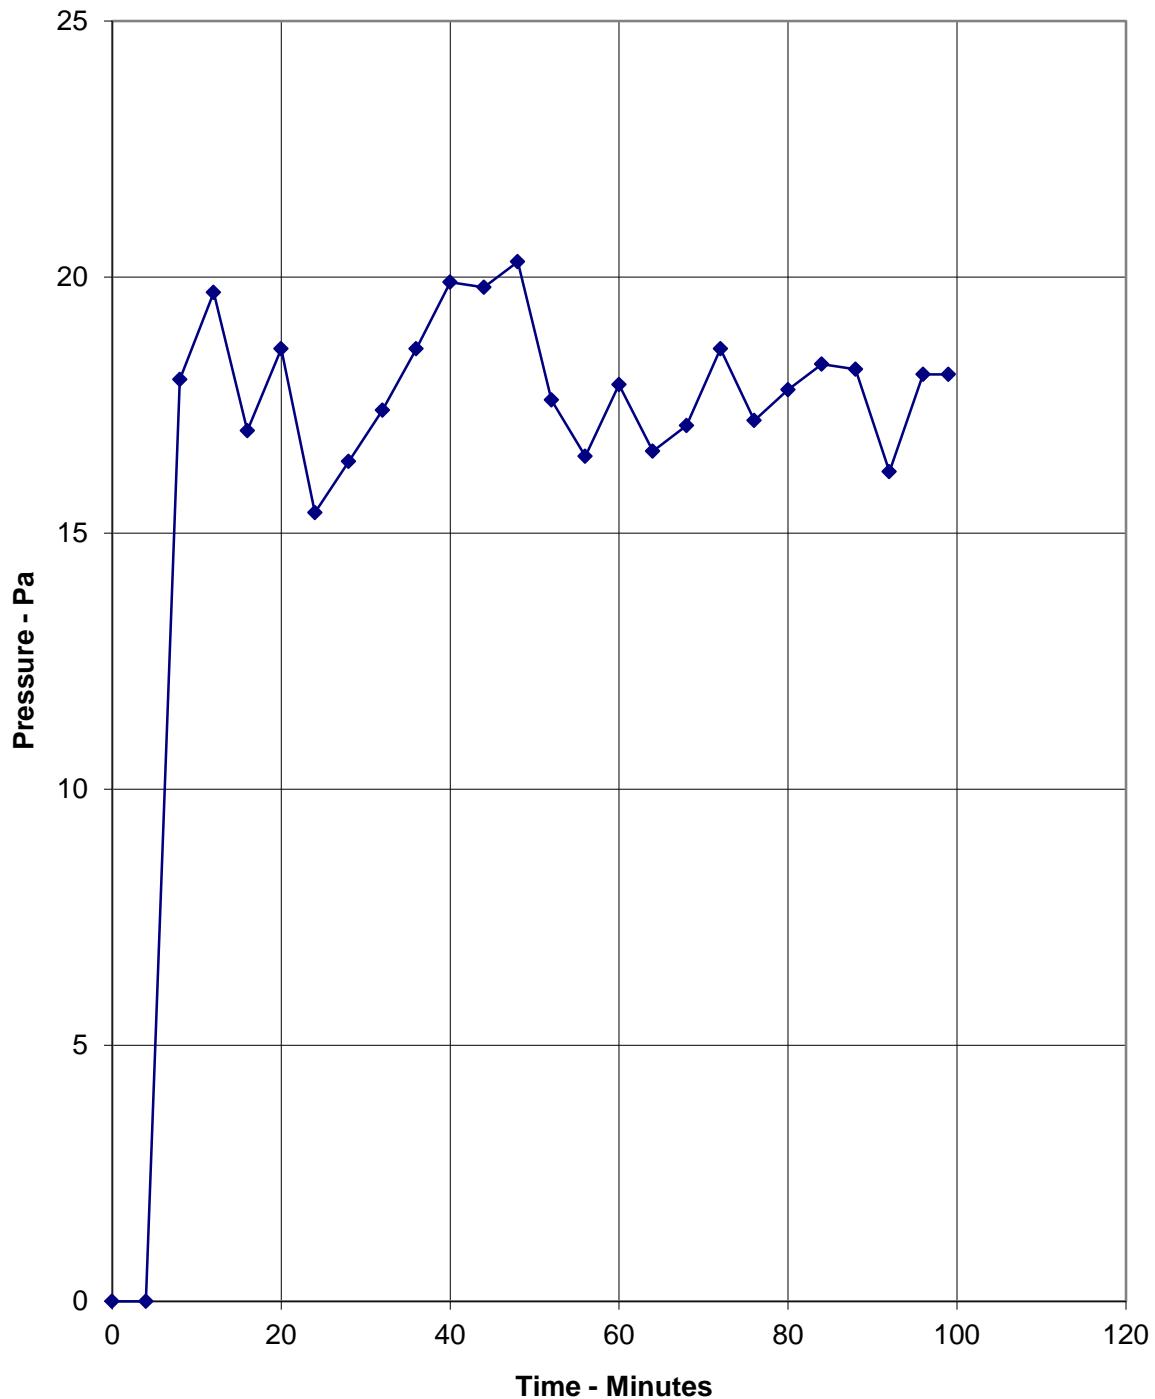
**Graph Showing Recorded Furnace Pressure 450 mm Below The Specimen**

<b>Furnace Pressure</b>	After the first five minutes of testing and for the remainder of the test, the furnace atmospheric pressure was controlled so that it complied with the requirements of BS EN 1363-1: 2012, clause 5.2.1. The calculated pressure differential relative to the laboratory atmosphere 100 mm below the specimen was 20 ( $\pm$ 5) Pa between 5 and 10 minutes and 20 ( $\pm$ 3) Pa thereafter.
